APPENDIX A

Exploded and Overall Views of the Example Servovalve Input Linkage Components

Elevator Power Control Actuator, Part No. 282700
 IPL Figure 1 (Sheet 2 of 3)

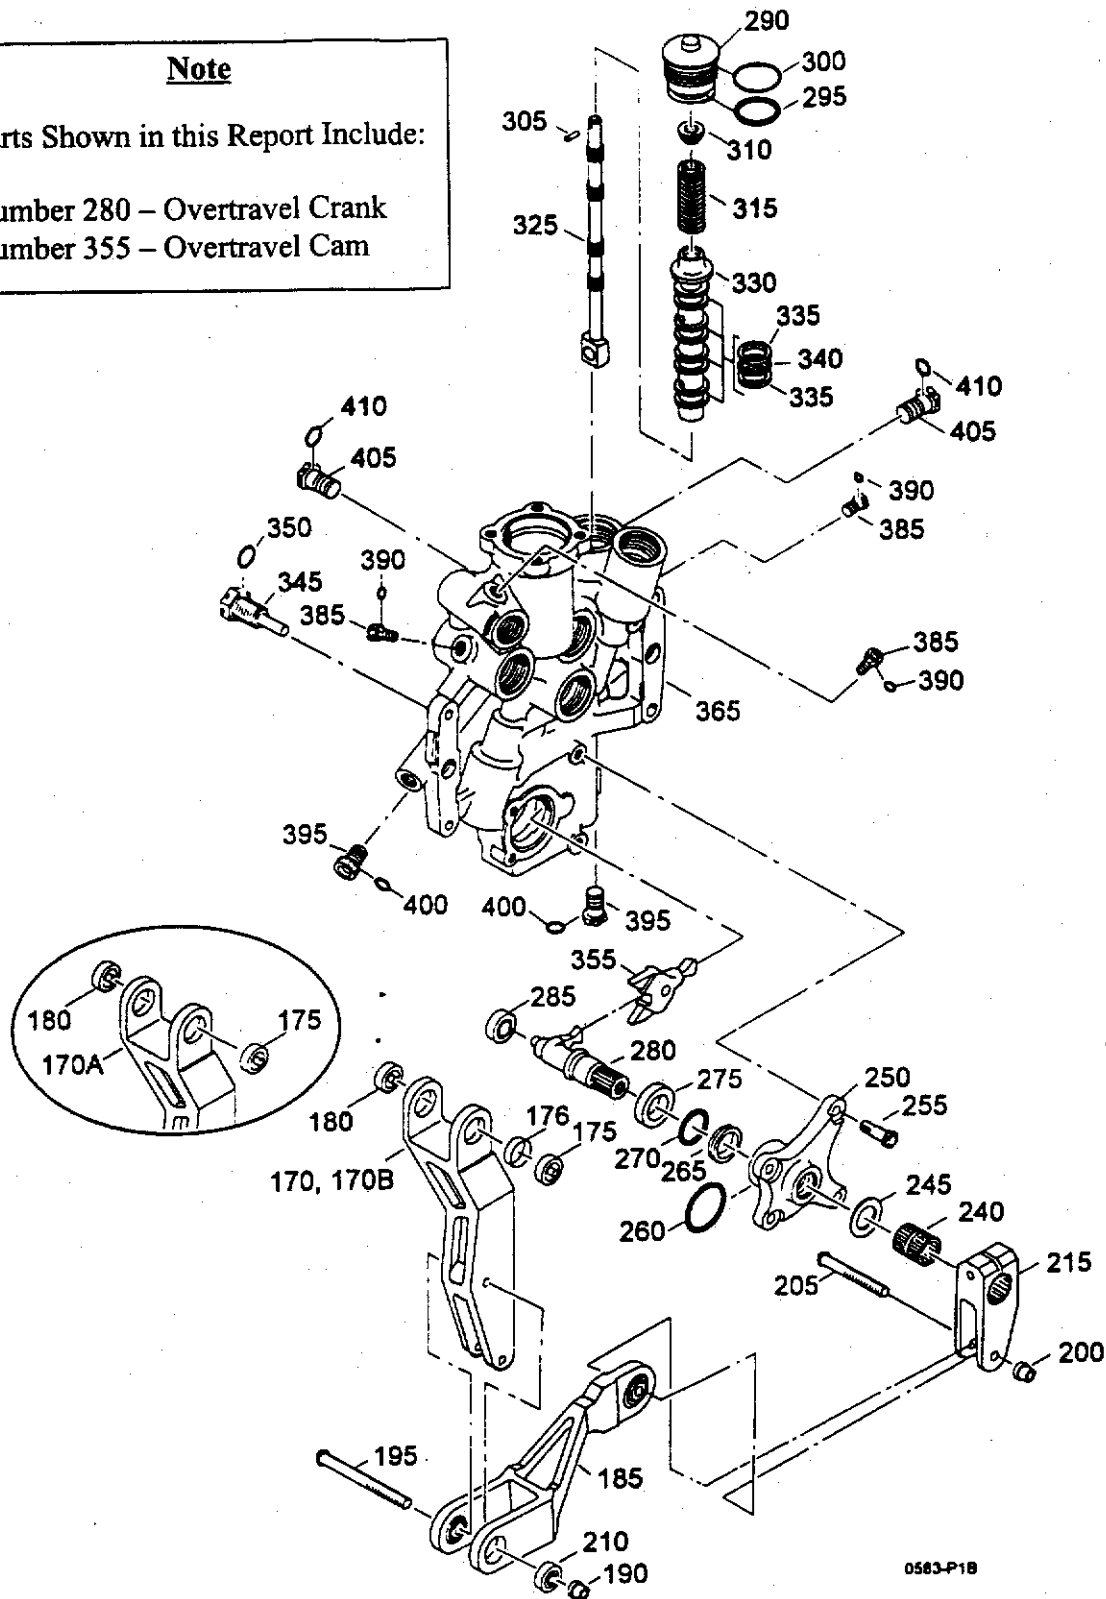
Parts Shown in this Report Include:

Number 280 – Overtravel Crank

Number 355 – Overtravel Cam

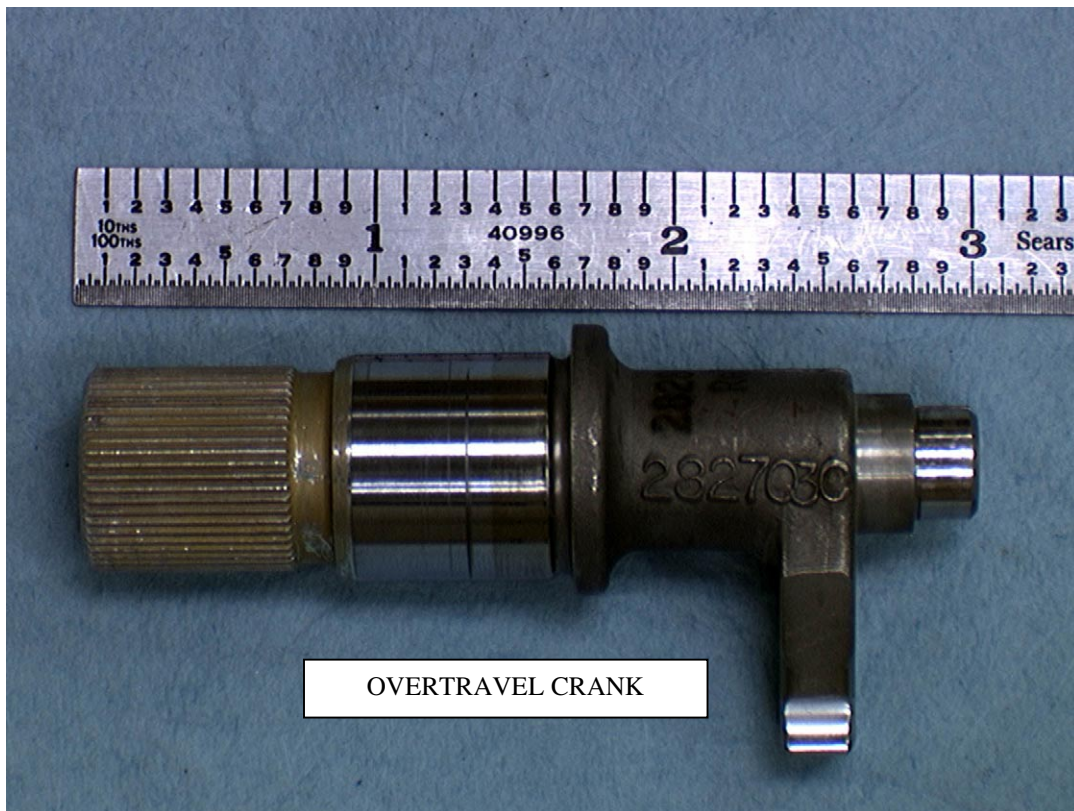
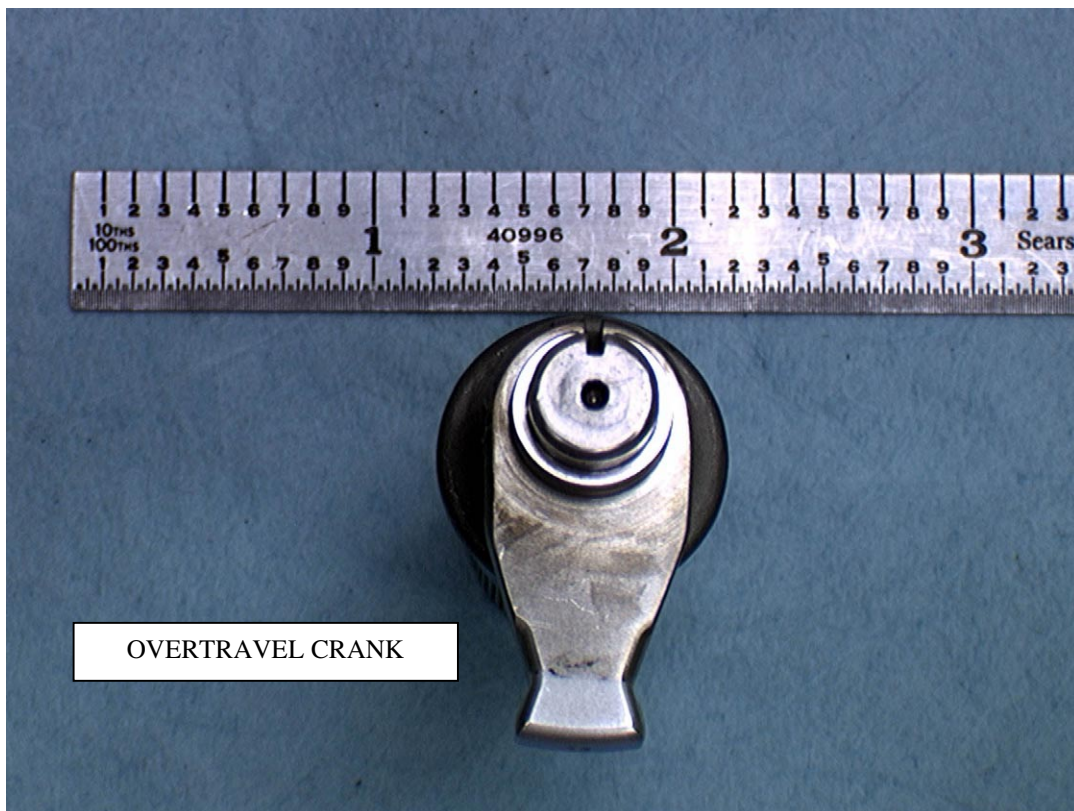
Figure 2 – Example of Overtravel Crank from Servovalve Input Linkage

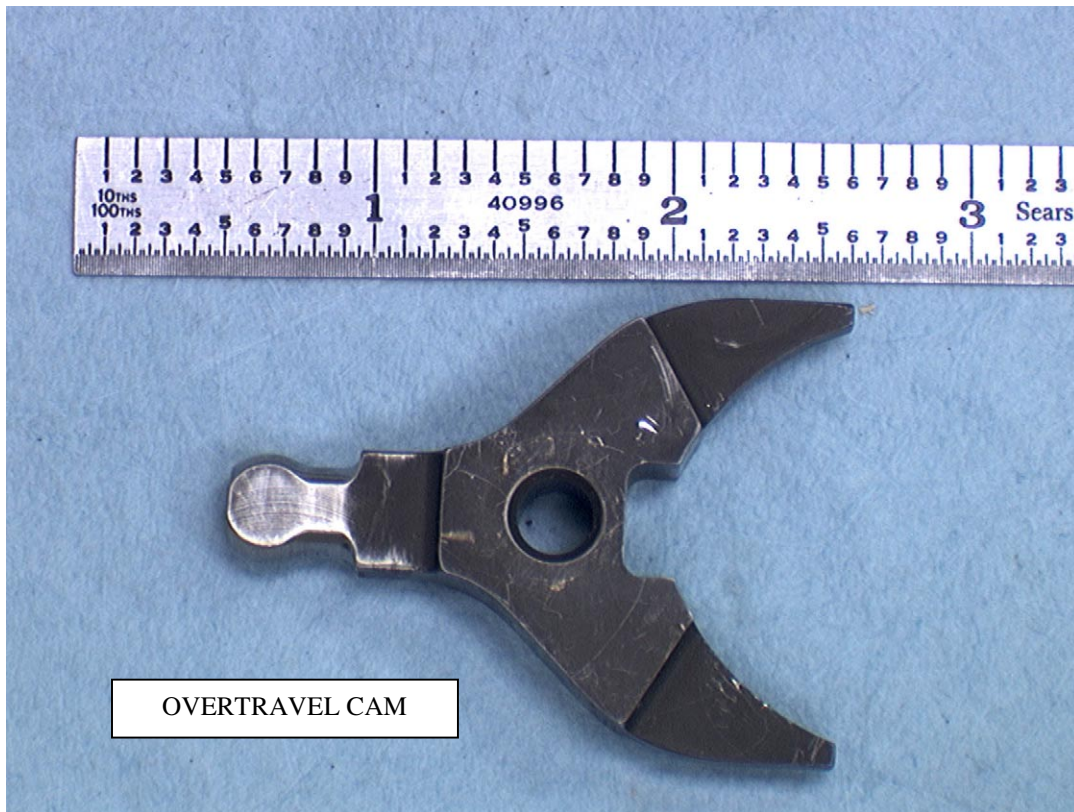
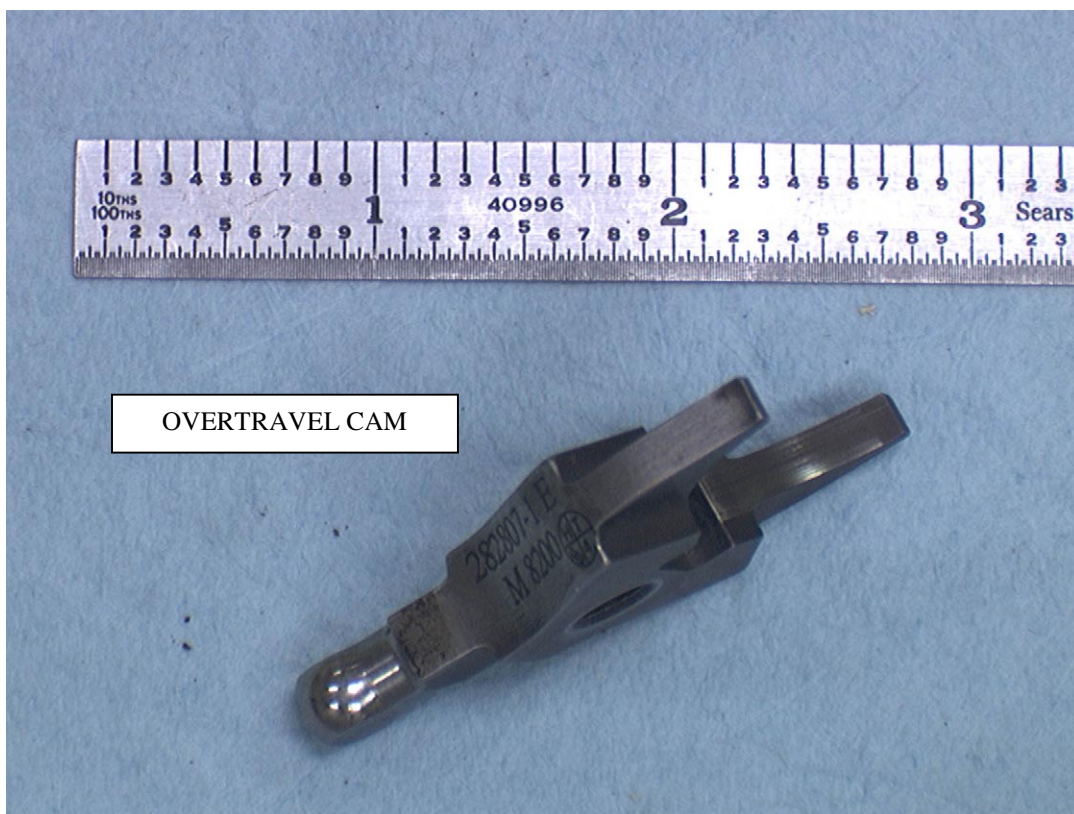
Figure 3 – Example of Overtravel Cam from Servovalve Input Linkage

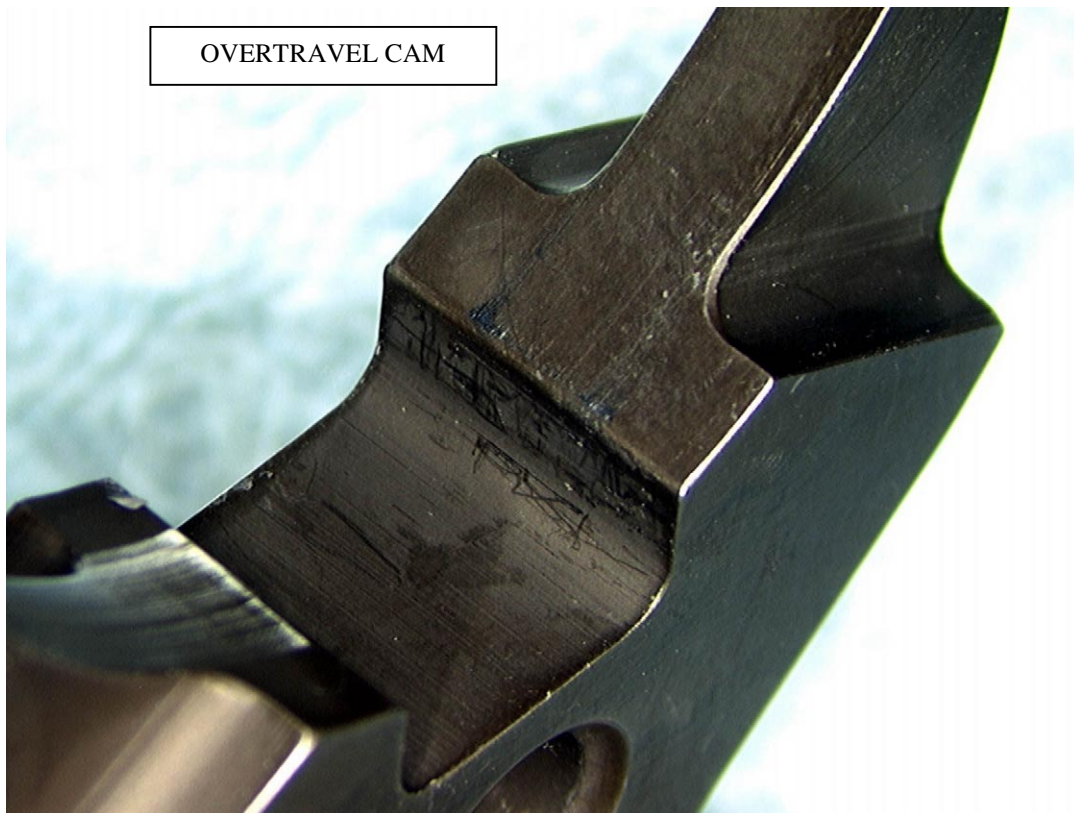
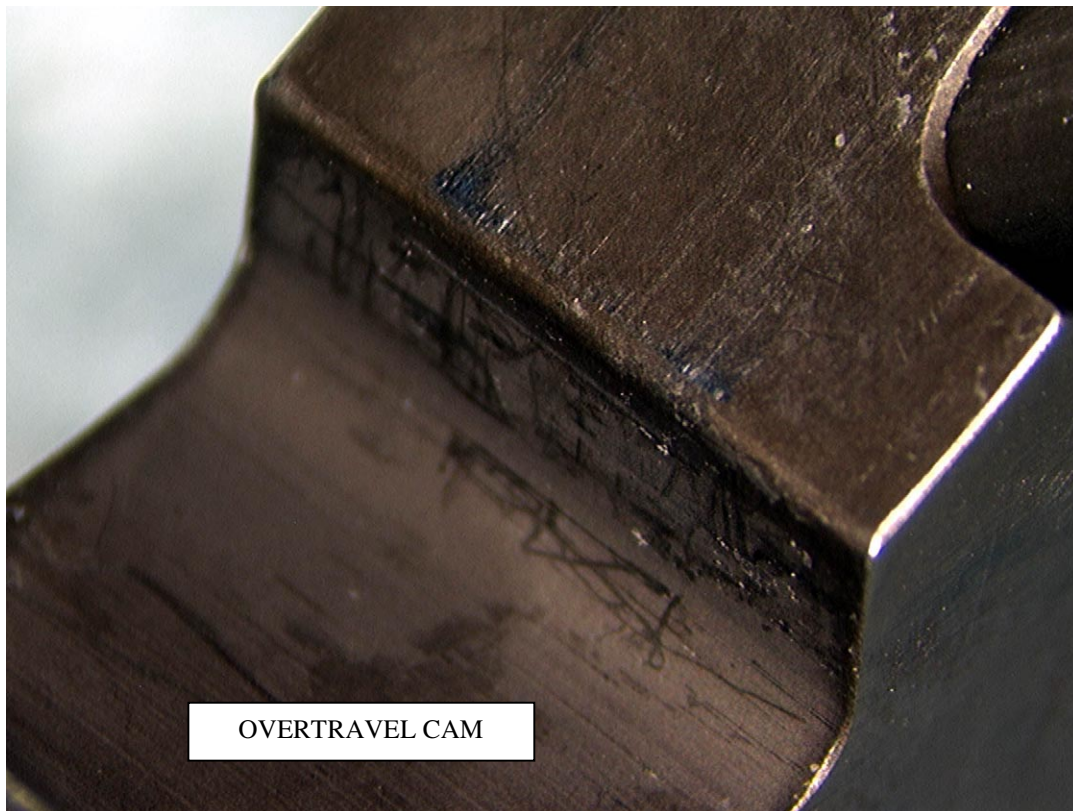
Figure 4 – Example of Overtravel Cam from Servovalve Input Linkage

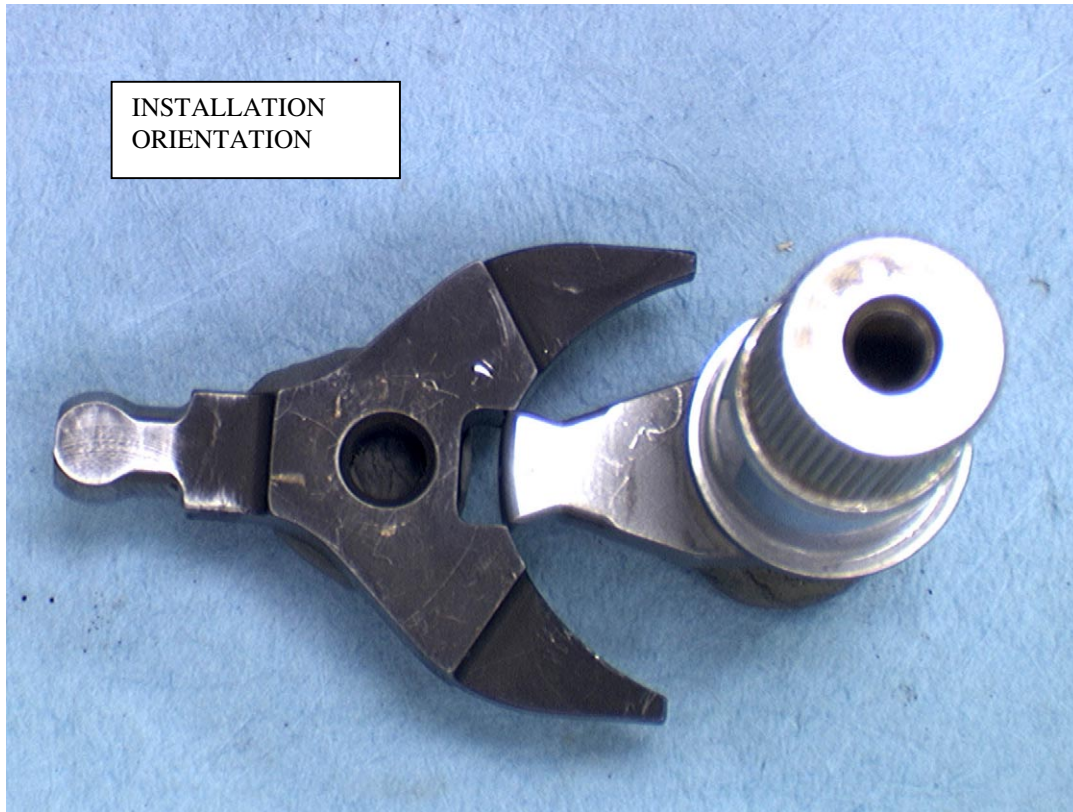
Figure 5 – Example of Installation Orientation for Overtravel Crank and Overtravel Cam from Servovalve Input Linkage
